**Archaeological observation, investigation and
recording at the Church of St Mary the Virgin
Badby, Northamptonshire
January-March 2018**

Report No 18/106

Author: Stephen Morris

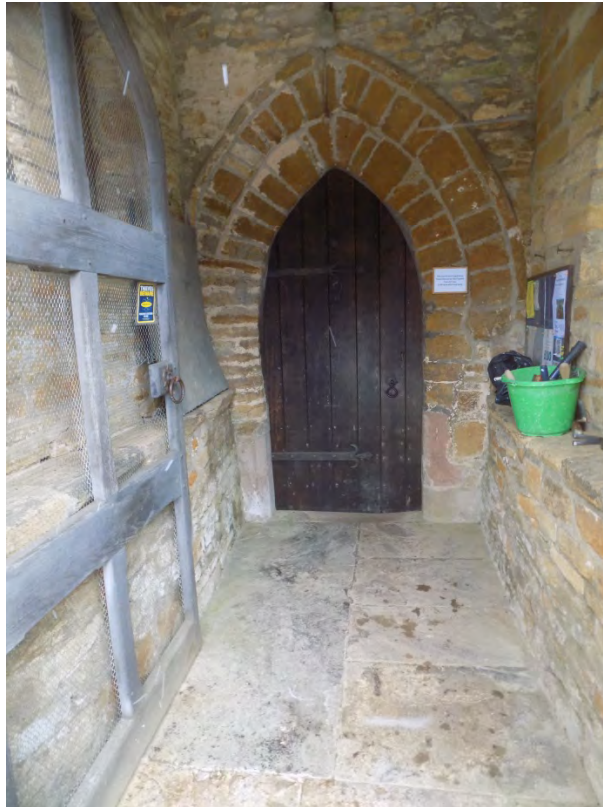
Fig 3

South porch entrance (pre-excavation), facing north

The area below the floor of the south porch was underwent the most detailed investigation, recording a series of three soil horizons, each containing a sequence of burials, dating from the construction of the church in the 14th century to the addition of the probable 16th century porch (Figs 2 and 3). The earliest buried soil Level 1 horizon (65) contained human remains, which may represent the remains of an early cemetery. The stone foundations of the church were cut through this layer, with no evidence of an earlier church structure.

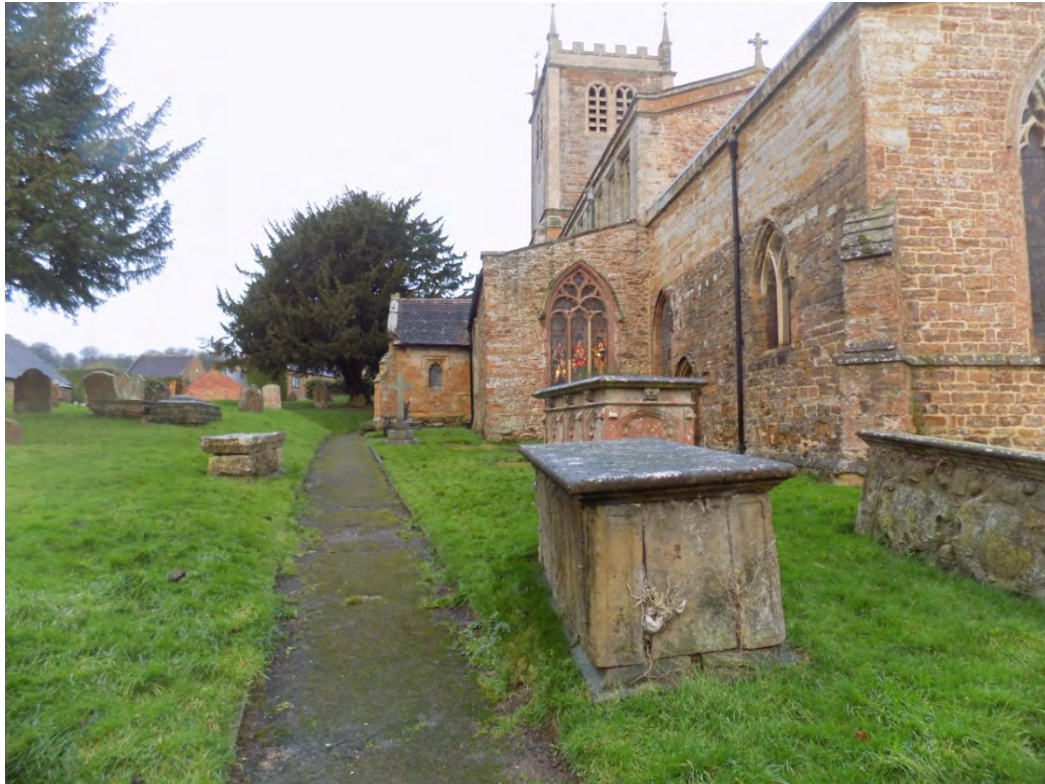
Churchyard path, leading to the south porch (pre-excavation), facing west Fig 4

A watching brief was undertaken along a service trench cut through the path access from the porch towards the eastern gate of the churchyard (Figs 2 and 4). The remains of a further 27 individuals were identified and only seven were briefly recorded on within the church grounds. At the request of the diocese none of the burials underwent detailed analysis and the remains were stored on the church

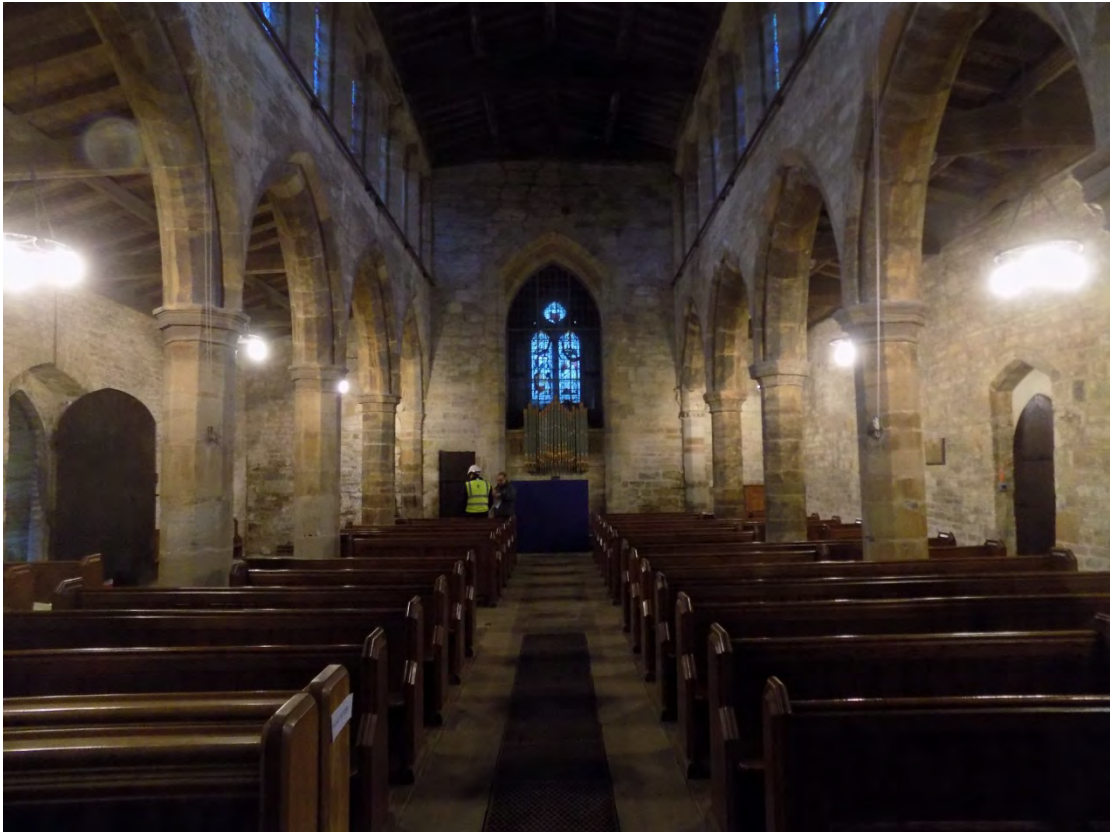
Church nave and aisles (pre-alterations), facing west Fig 5

The main area of investigation carried out inside the church where the raised floor in the nave was removed overlying a series of bays (Figs 2 and 5). This revealed two of the medieval pier bases still displaying some of the original mortared stone foundation, which may represent part of an earlier church structure.

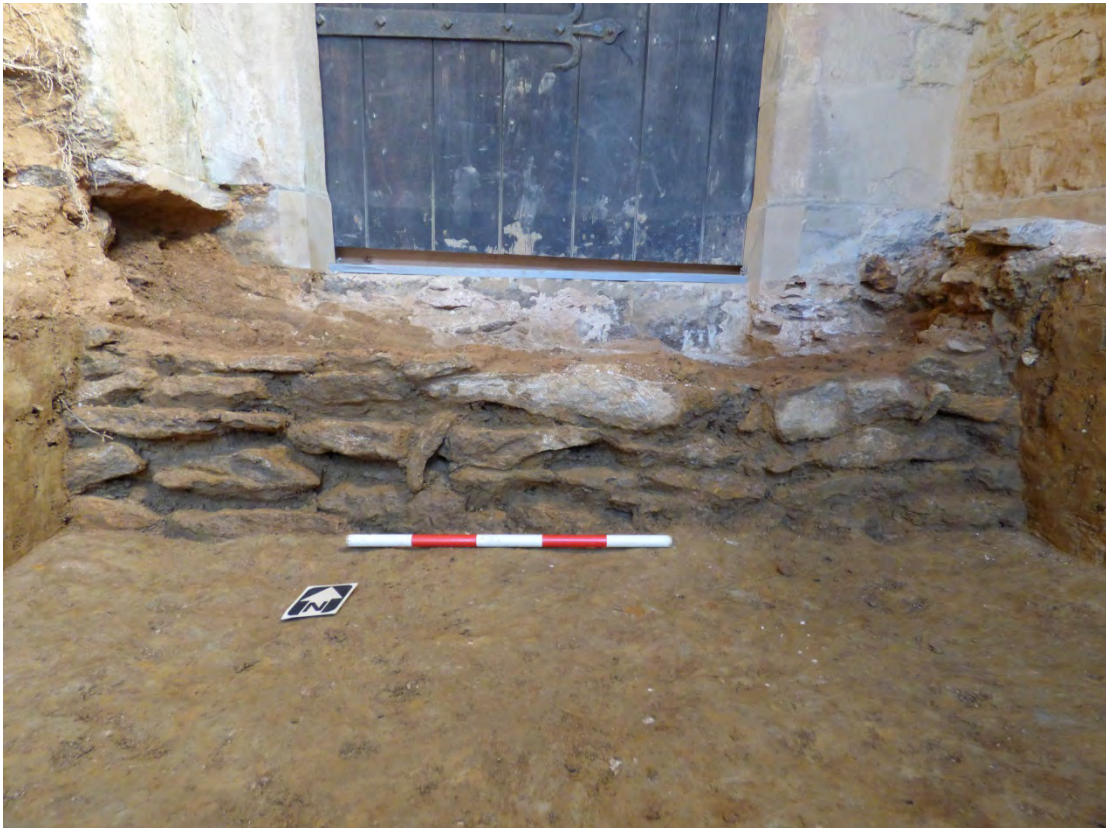
The foundation comprised 7 to 8 visible courses of roughly faced and unbonded limestone/ironstone blocks and slabs, the largest with spans of 0.4m long and 0.1m in thick. The top of the wall foundation stood at c142m (aOD), although several courses, possibly up to four had been removed from the foundation, across the width of the doorway, forming a slot c1.2m wide and 0.2m-0.3m deep, but its original height was visible either side. It appears to suggest the foundation wall had been cut through for the establishment of a new level for the present doorway, possibly at the time of the porch construction (Fig 7).

Nave wall foundations [45] cut through for the present south nave doorway. Level 1, soil horizon (65) in foreground, facing north Fig 7

As noted above the upper courses of the nave wall foundations were cut through to create a level with the porch floor, with a small door step into the church nave. The arched doorway laid slightly off-centre to the west of the porch, with walls of the porch walls abutting the doorway structure. This may suggest the door was in place prior to the porch construction. The main structure of the arched doorway comprised coarse blocks of Northampton sand-ironstone, although the lower structure was composed of moulded ashlar blocks, implying the doorway had undergone restructuring possibly at the time of the porch build.

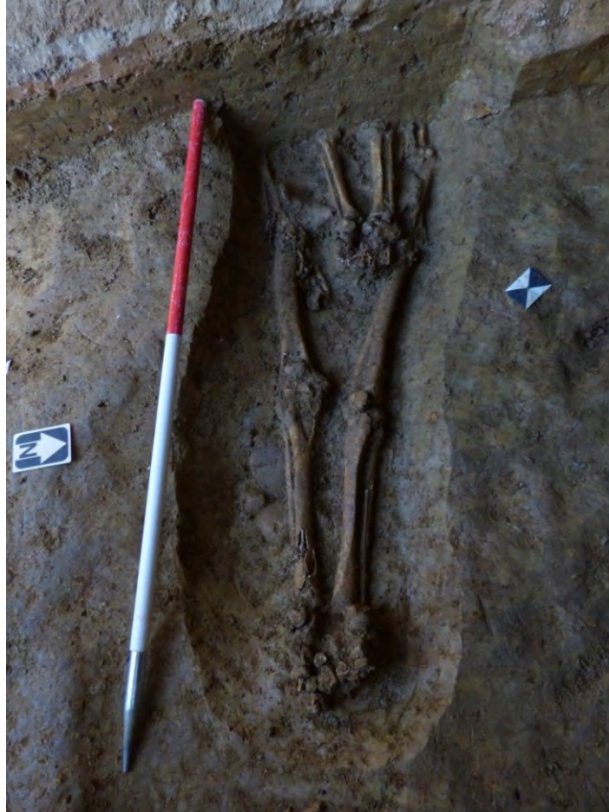
Level 2 burials; adult Burial 18 overlaid by child Burial 17, facing west Fig 10

Burial 18 was at least 1.15m long and 0.45m wide and lay at a slightly oblique angle to the nave wall that was c0.50m away at the nearest point. Burial 17 directly overlay the upper part of Burial 18 (Fig 10). Only the eastern half of the grave of Burial 18 was an adult and lay within the porch excavation. The skeleton remains comprised the legs and the lower arms and hands lying across the pelvic area.

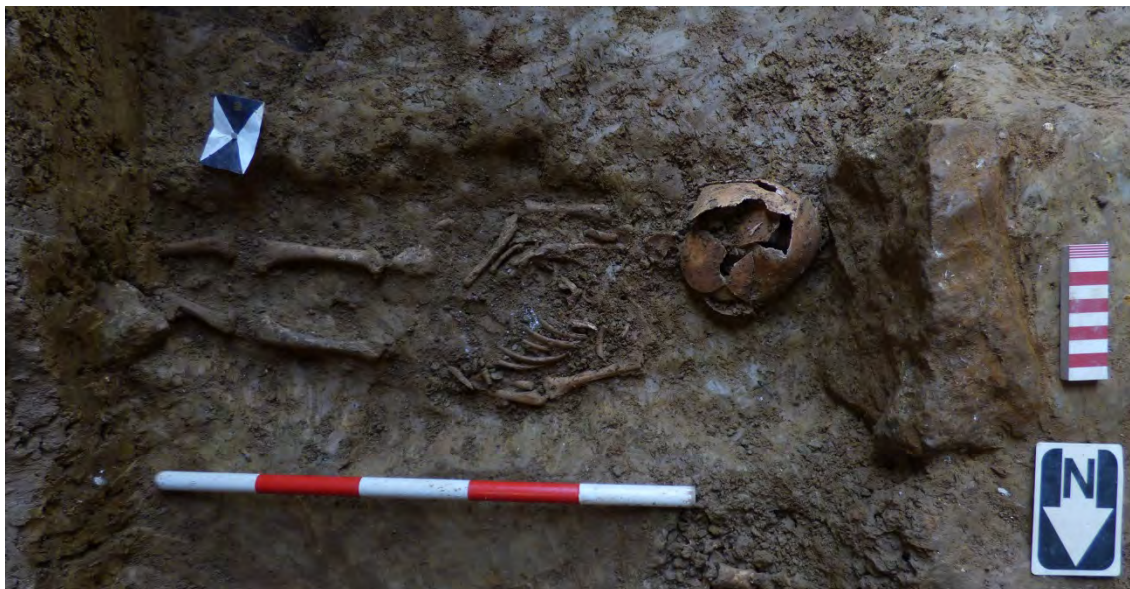
Level 3 burial; Child Burial 5, with a pillowstone, facing south

The stone comprised a large 0.25m sub-square roughly cut ironstone block, up to 0.1m thick, pitched at the west end of the grave cut. The final resting position of the skull was angled facing down the grave towards the feet. A smaller stone block lay to the left side of the lower left leg. It was possible the two stone were used to support a wooden lid laid over the child burial that has totally decayed away.

Adjacent to the north side of Burial 2 was a child Burial 5 that was an almost complete skeleton and in good preservation. The whole of the skeleton was exposed inside the porch, except for the feet, which lay below the east wall of the porch. It lay in a grave cut at least 0.8m long and 0.35m wide (Fig 12). The interesting feature of this burial was the large pillow stone on which the head rested, a feature not observed with any other gave.

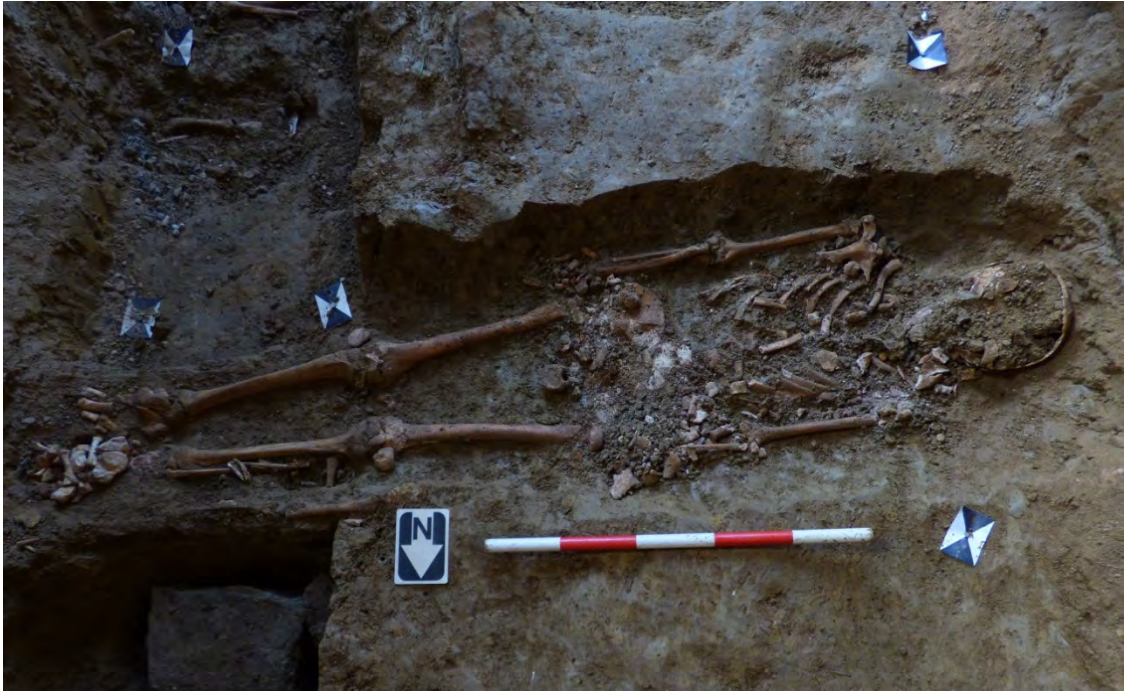
Burial 3 was aged to the early teens and lay to the north side of Burial 5 and c0.4m from the nave wall foundations (Fig 13). This was the most complete burial as it lay between the walls of the porch, although some loss of the upper part of the skull probably occurred during the construction. This burial was also recovered for full analysis and is reported on below.

Level 3 burials; Teenage Burial 3, background, facing south Fig 13

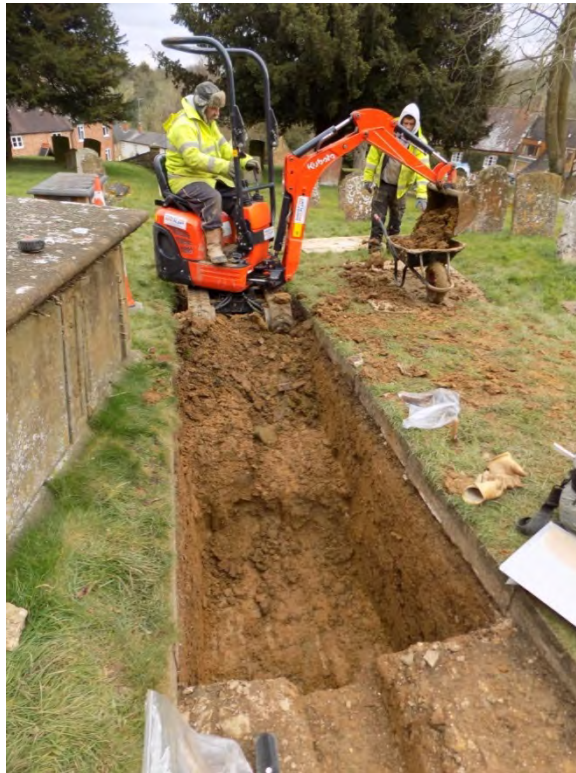
The service trench for a soakaway was excavated through the churchyard footpath from the porch to the north-east of the churchyard for c32.5m. A mini-excavator with an 0.8m wide bucket was used to dig a trench, centred on the middle of the path from the porch for the first 24m, from which point it was widened to the full width of the 1.8m wide path. At the west end of the path, opposite to the porch entrance, there was a 3m long extension of the trench up to the drain that led from the church. The depth of the narrow service trench was between 0.5m and 0.7m from the surface of the path and increased to 1m to 1.2m where the trench broadened (Fig 14).

Service trench excavation along the churchyard path for the new soakaway. The transition point between the narrow and broad trenches, facing east Fig 14

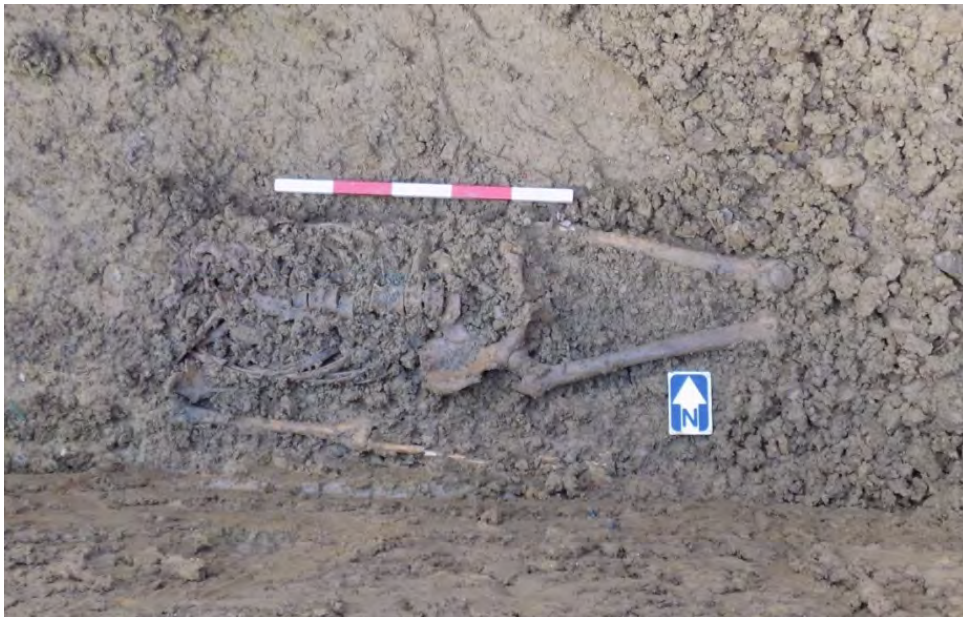
Burial 14 was in a better condition compared with burial 13 (Fig 15) and was found with two notable artefacts, a lead-alloy paten (SF 6, Fig 23), which lay flat across the abdominal area and lead-alloy chalice fragments (SF 5) lay over the left arm, which lay slightly flexed over the left pelvis. The chalice may have initially lain on the paten or next to it in the abdominal area. These finds suggest this was the remains of a priest. These vessels date the burial to the later medieval period or earlier.

Burial 14, a possible priest burial, buried with a pewter chalice and paten Fig 15

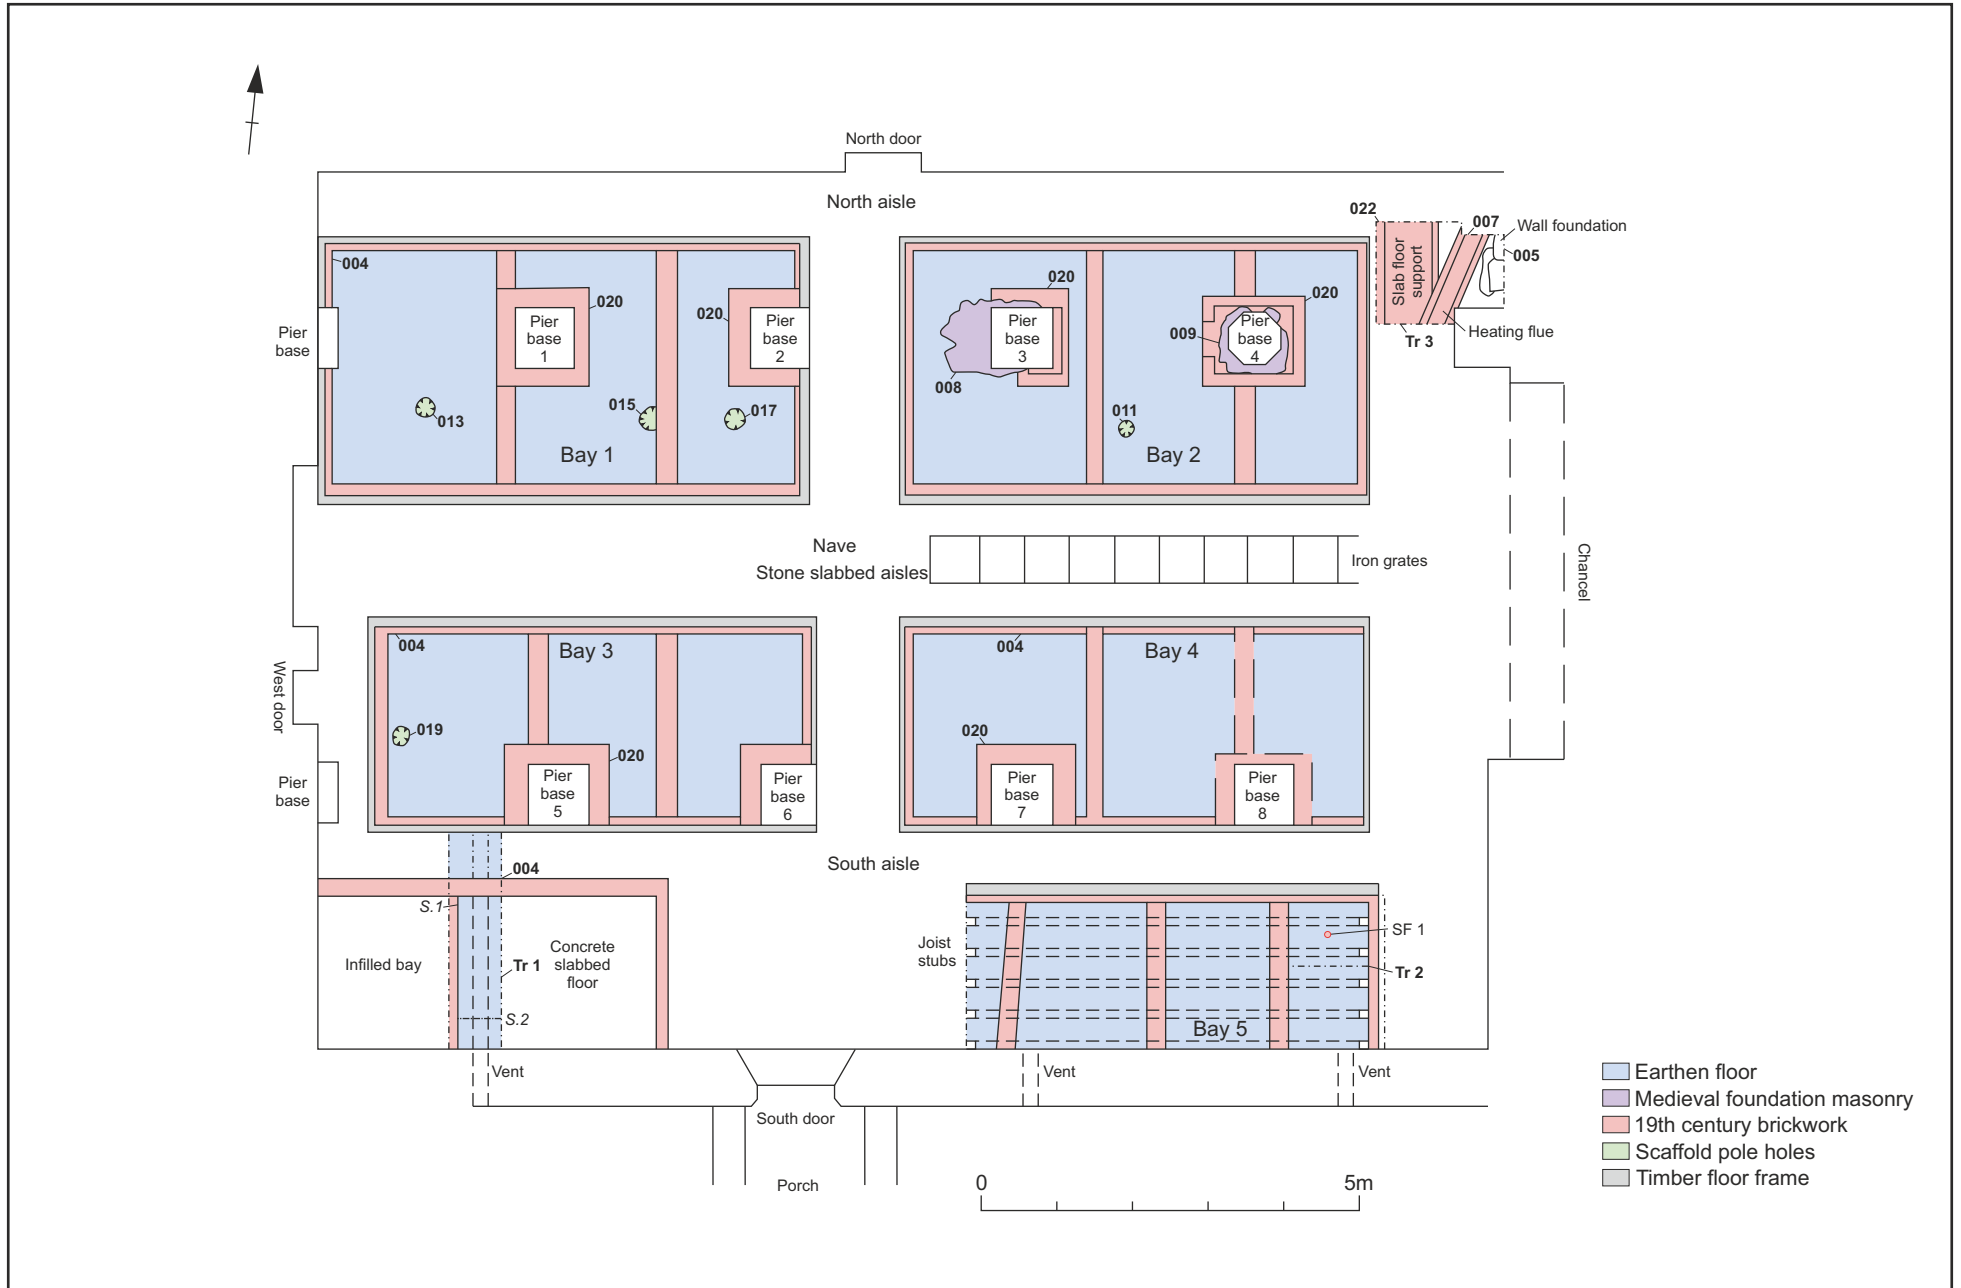
Fig 16

An observation and recording action was carried out inside the church where five of the bays of the nave had their pews and raised wooden floors removed for repair or replacement (Fig 16), with a new platform construction at the west end of the nave. Two smaller areas of the floor area (T1 and T3) were also opened to update the ventilation ducts (Fig 16). Other work included moving the font from the west end of the south aisle to the eastern end to be placed in trench T2 (Fig 16).

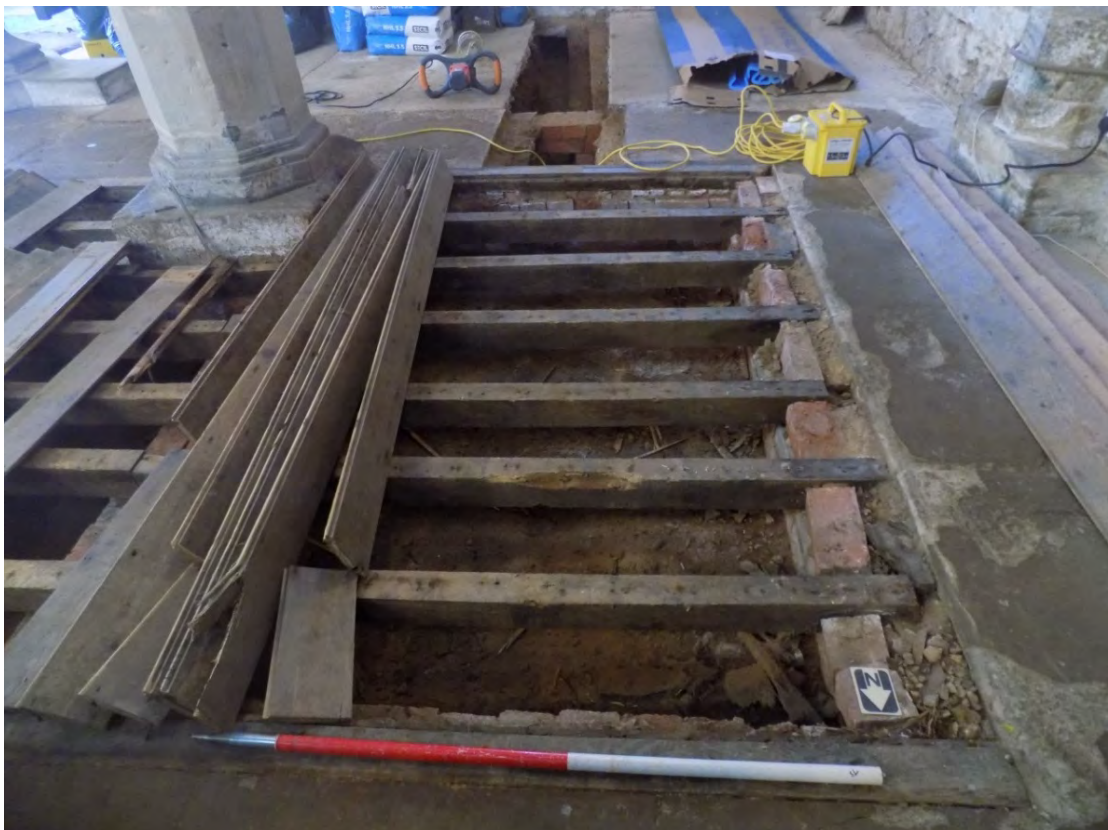
The wooden joists were laid east-west across the bays, sitting between single stretcher laid bricks in the upper course of the (east-west) walls (Fig 17).

Bay 3, displaying floorboards (lifted) and wooden floor joists supported on the bay wall, facing south towards trench T1 (background) Fig 17

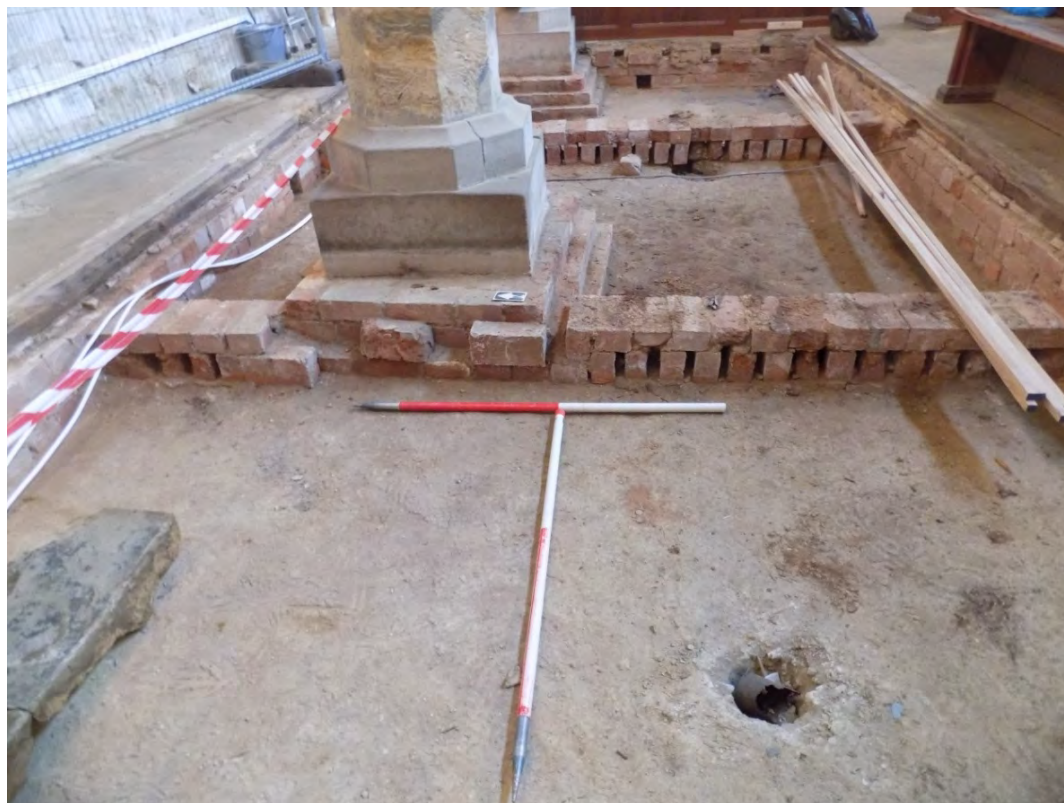
The bays were sub-divided by two north-south brick piers, lying between 1.4m-1.9m apart (Fig 18). They displayed a single brick less in height than the surrounding bay lining wall, so as to support the wooden joists directly on the top course. The south aisle Bay 5 contained three dividing piers (Fig 22). The dividing piers varied from the bay lining walls in that the lower course(s) that were constructed with alternating brick piers and gaps of an equal header width, to allow venting across the bay. Vents were observed in the lining walls of the bays, possibly indicating all the bays were connected to ventilation or heating system (Fig 22).

Bay 1, displaying the brick piers and the brick underpinning of the bases of the arch pier supports 1 and 2. Three scaffold post holes are also visible east-west cross the earthen floor (3), facing east Fig 18

A series of four postholes were cut into the soil layer (3), forming a line c9m long across the two open bays (1-2) of the north aisle of the nave (Figs 16 and 18), with a single posthole in Bay 3. They were all probable scaffold postholes, relating to the 19th century restoration work. They were generally very circular and c0.1m diameter, with two displaying very vertical sides, whilst the others were disturbed possibly when the scaffold poles were removed. They were only partially filled with loose debris and the contents of china pottery and a tin can from one of the holes appeared to confirm this late date.

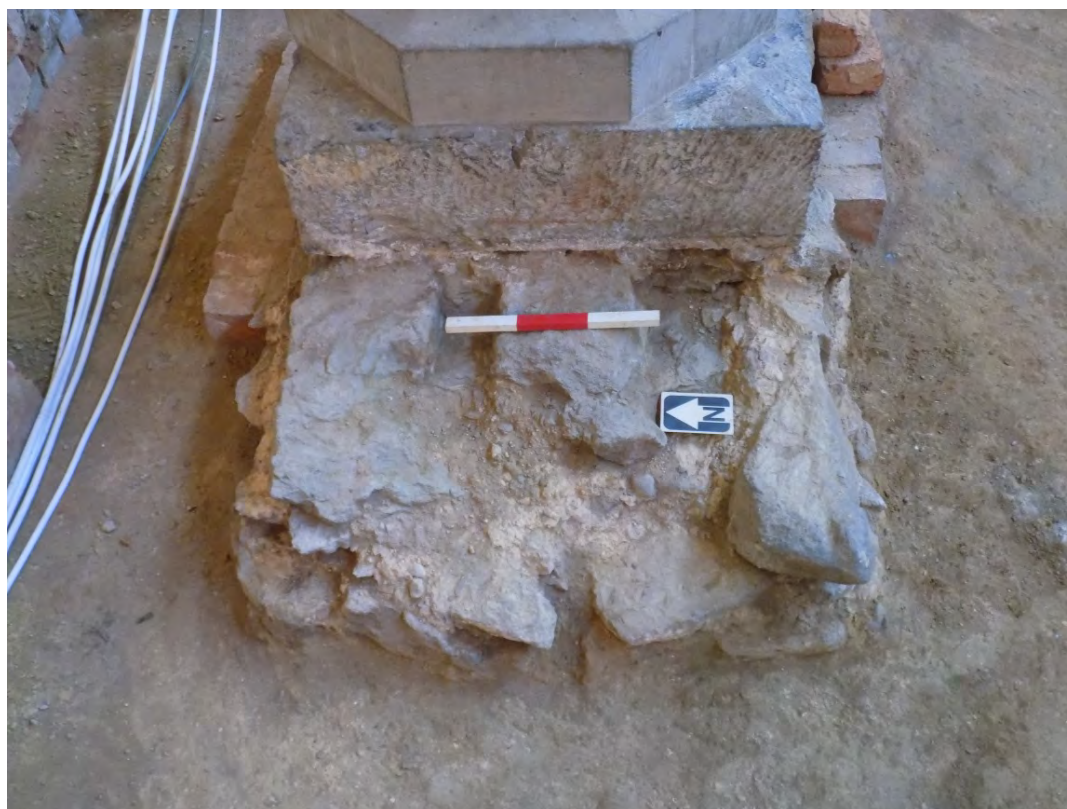
Bay 2 nave arch pier 4, with early stone and mortar foundations, facing east Fig 19

The two pier bases 3 and 4 in Bay 2 in the north aisle still displayed the original lime mortared stone footings (8) and (9) up to c0.8m wide, which comprised large limestone blocks. The foundations (8) of pier base 3 extended 0.4m to the west of the pier base on an east-west alignment and displayed roughly faced stone on the north and south sides, indicative of a wall or foundation remnants (Figs 16 and 19).

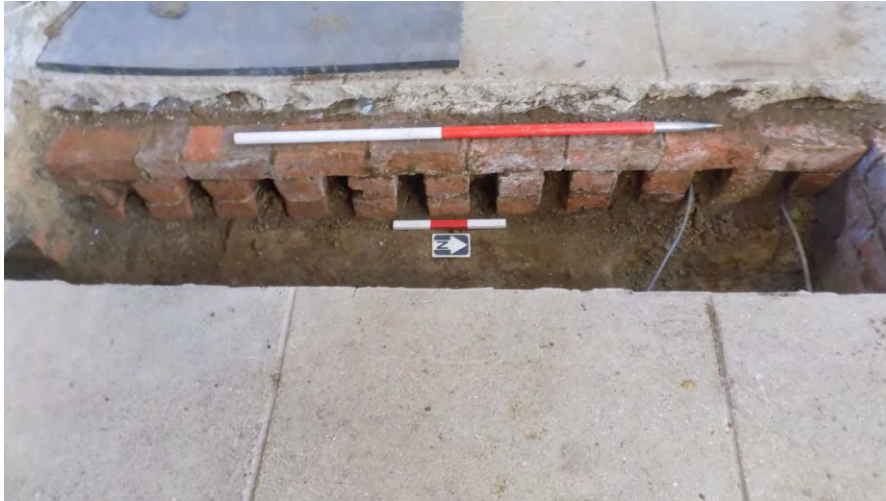
Trench 1, section 1 - looking west

This trench was located in the south-west corner of the nave that had previously undergone groundwork, where the floors, had been replaced with a concrete surface (1). A 3m long and 0.7m wide slot was cut from the north wall of the nave and through the south aisle to the Bay 3 at the west end of the nave, for the insertion of a new ventilation duct (Figs 16 and 20).

The slot revealed a section through a backfilled bay at the west end of the south aisle, exposing the outer bay brick lining wall and one of the north-south aligned brick piers (Fig 20, section 1), which formerly supported the joists for a raised wooden floor, but were no longer present. The infilling of the bay comprised a stone rubble debris (2), acting as a make-up layer and sub-base for the 20th century concrete floor. The stone slabbed floor of the south aisle also had a stone and rubble bedding as noted previously.

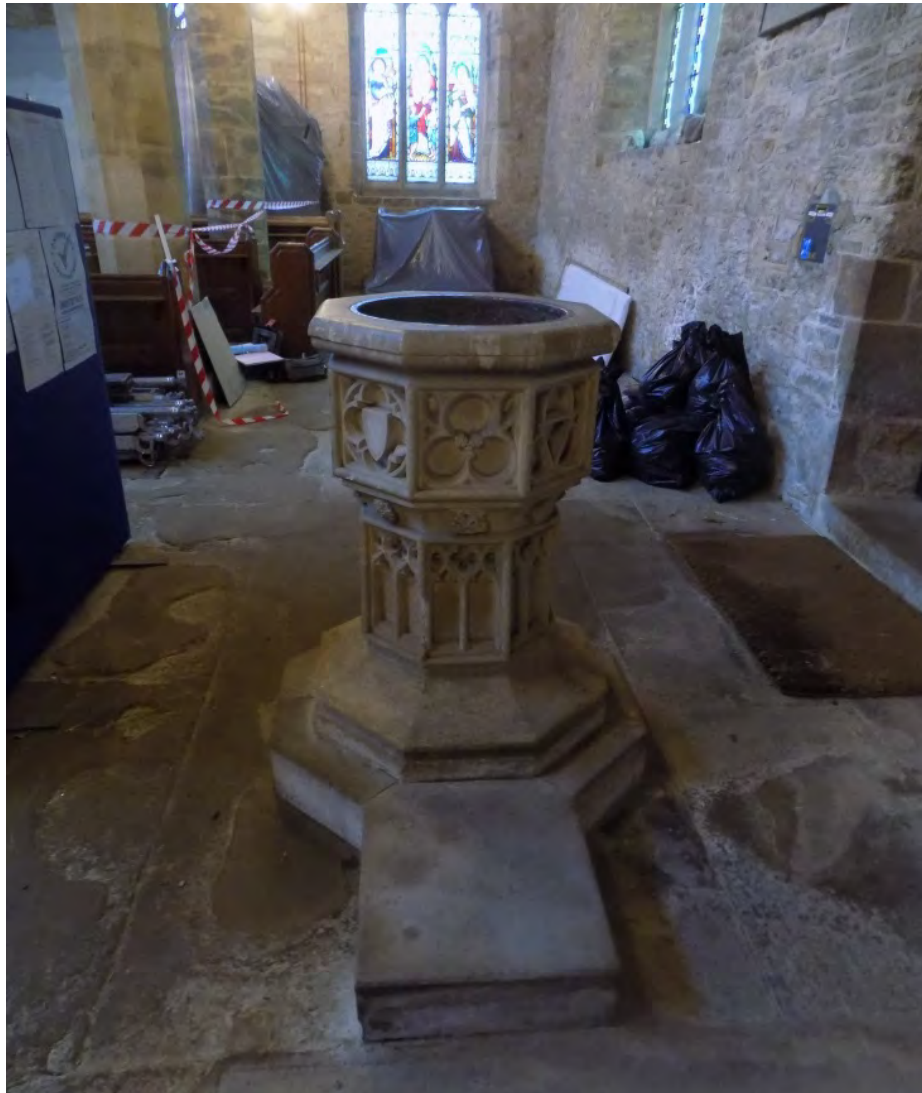
As part of the renovation work the font with a 15th century pedestal (Figs 16 and 21) was moved from the west side of the south entrance to the east end of the south aisle Bay 5 in Trench T2 (Fig 22). A shallow Trench T2 measuring 1m by 0.8m was excavated into the earth floor (3) in the north-east corner of the bay between the bay lining walls and the supporting pier. A complete late 19th century floor brick lay loose on the surface of the soil layer.

The church font, south porch entrance (left), facing east Fig 21

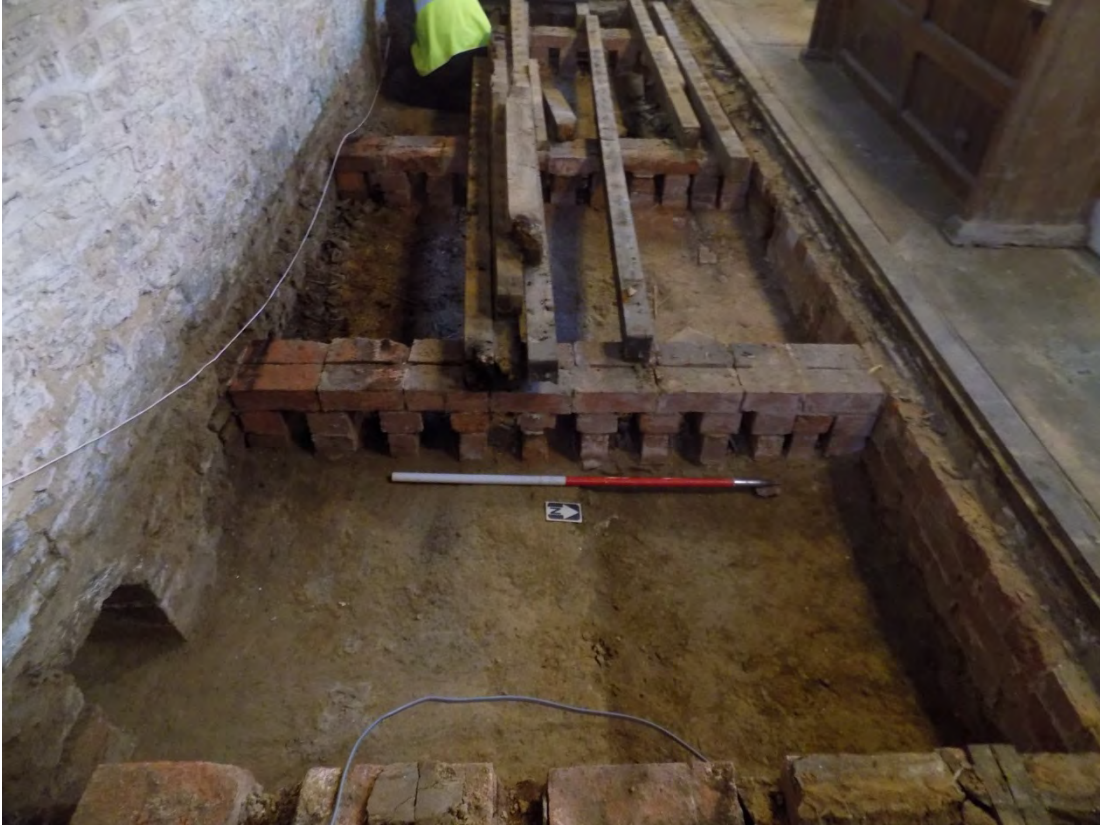
The trench went only 80mm deep into earthen floor (Fig 22). A few fragments of disarticulated human bone were retrieved (finger and rib bones) from this layer as well as a copper alloy buckle. The buckle (Fig 25, SF1) is oval in shape with a recess for retaining the pin. Buckles of this type are not uncommon and are dated to the late 14th century.

Bay 5, south aisle and brick bay wall (right), floor joist slots visible in brickwork (foreground), nave wall with vent cut (left), dividing brick piers (mid-ground to background) Trench 2 (right, foreground), looking west Fig 22

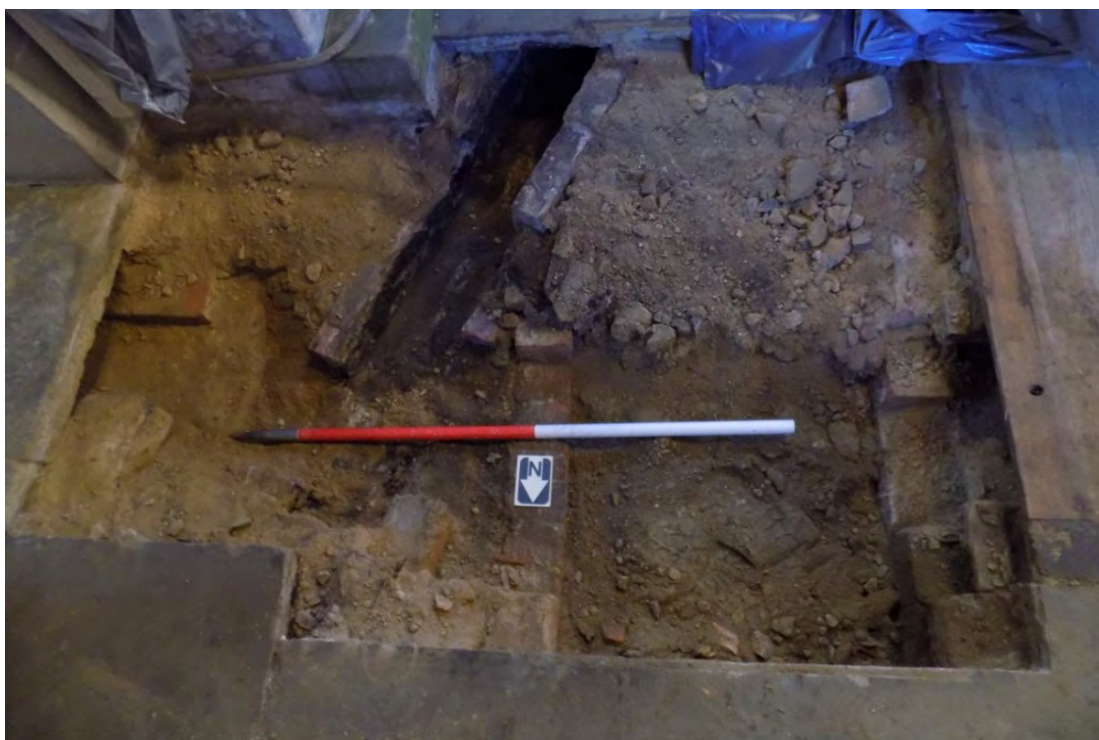
A third Trench T3 (1.7m by 1.3m) was excavated below the stone slab floor in the north-east corner of the nave opposite the door in to the vestry. It revealed a pair of low parallel north-south aligned brick walls [22] cut by a former 19th century brick lined heating flue duct [7], and both were infilled with loose soil and rubble (Figs 16 and 23).

The brick walls [22] were single lines of mortared bricks (header on) lying c0.6m apart, with space between them filled by stone and brick rubble. This was probably part of the structure to support the slabbed aisle floors. The heating duct [7] was 0.2m wide and two bricks in height, capped by the slab floor. The removal of the debris infill revealed the duct to be soot lined as result of being a heating flue. The flue appeared to be aligned with the under floor heating in the nave below the iron grated floor.

Trench 3, north-east corner of the nave, comprising slab floor support walls [22] (right) that were cut by brick lined flue [7] (centre) and the stone chancel wall footings [5] (left) lay below the vestry doorway, looking south Fig 23

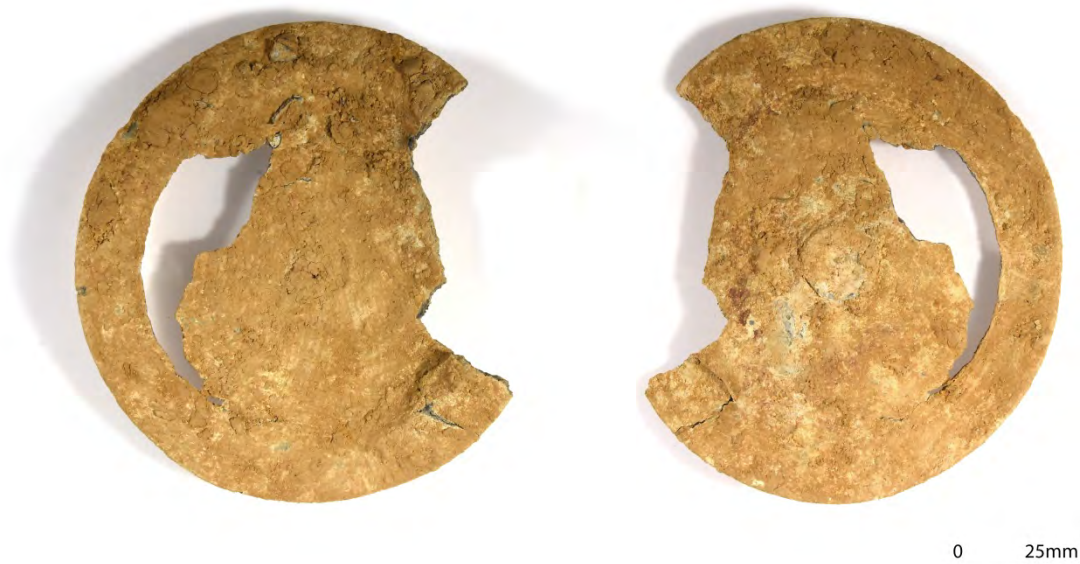
SF 6, Pewter paten, missing parts of the flanged rim and the body, recovered from fill (29) of grave cut [31], Burial 14 Fig 24

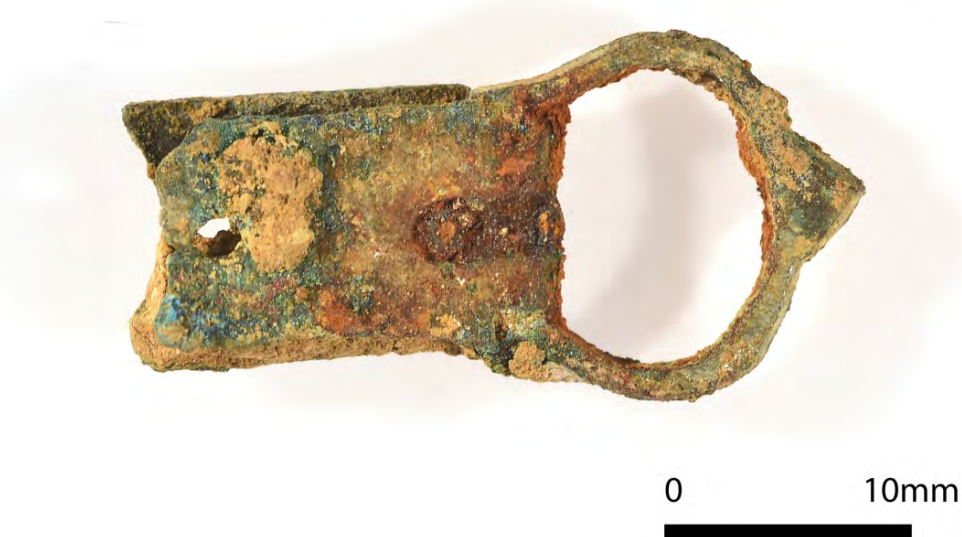
Also of later medieval date is a small copper-alloy buckle found on the nave floor (Fig 25). It is particularly narrow and probably came from a leather girdle rather than a more substantial belt.

SF 1, Small copper-alloy buckle and folded strap-plate, with iron staining from the missing buckle tongue, recovered from the earthen nave floor (3) Fig 25

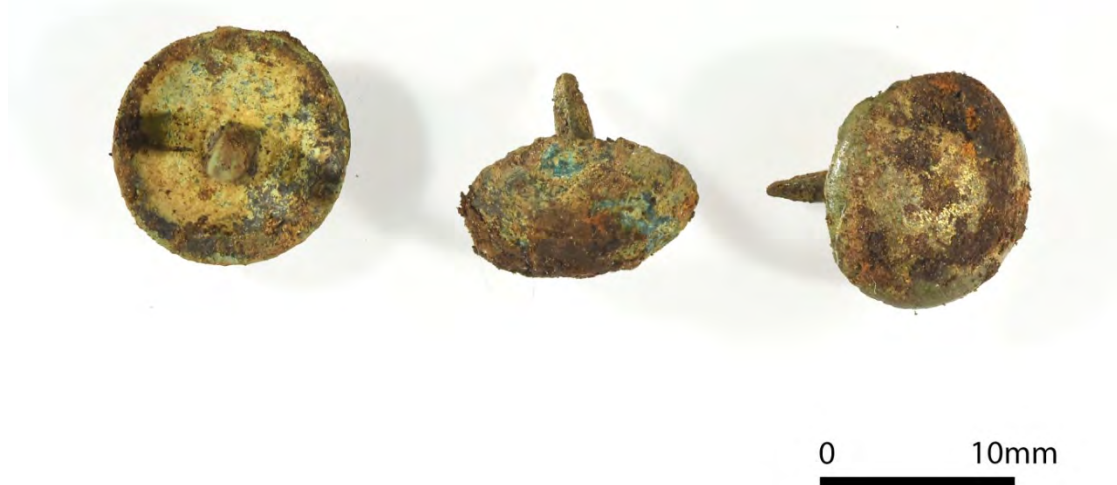
As well as coffin nails, Burial 13 contained 24 copper-alloy (probably brass) upholstery studs with low domed heads, most still fixed in decayed wood (Fig 26). The studs are 11 mm long and the ends of the shanks are not clenched; with the heads only about 1 mm high, this gives a wood thickness in excess of 10 mm, and by comparison with the panels of outer wooden coffins at Christ Church, Spitalfields, London, the Burial 13 coffin was likely to be about 25 mm thick (Cox 1996, 99). From their positions within the grave, it seems that the studs had been used to tack down a cloth coffin cover, and it may be that traces of decayed textile still remain beneath some of the stud heads, sandwiched between the metal and wood.

SF 2, Three of the twenty-four copper-alloy convex-headed studs, recovered from fill (26) of grave cut [28], Burial 13 Fig 26

The studs date the coffin to the later post-medieval (early modern) period, with cloth, often black, used to cover wooden coffins from the late 17th century; from the early 18th century the fabric might be glued or nailed down and then numerous studs were set in decorative patterns on the lid and side panels, even sometimes used to record the name and age of the deceased (e.g. Cox 1996, 102; Schofield 2016, 177; Boston 2009, 173-4; Schofield 2016, 177; Bashford and Sibun 2007, 112-13). Most of the wooden coffins in the vaults at Spitalfields had been covered in textile and beneath it the wood, usually elm but sometimes coniferous softwood, was left untreated and
